## Public health issues during MSC CHITRA (TICPE

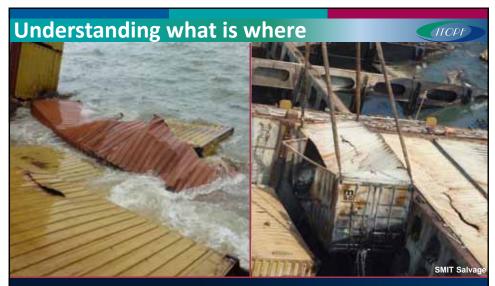
- During the salvage operation, one container with Aluminium phosphide broke open and the contents were lost in the hull and sea
- Contained 4,200 kg of AP in 2,800 x 1.5 kg canisters
- Reports received of canisters coming ashore

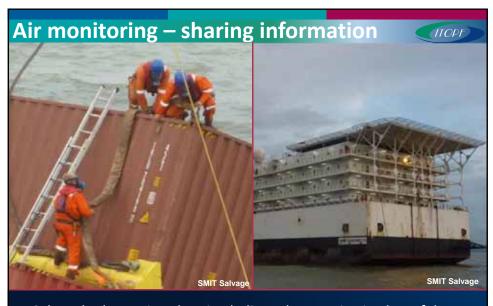
- Salvors had a marine chemist dedicated to monitoring harmful gases
- Varying levels of PH₃ detected; changed with wind conditions
- Respirators required to work in some areas; other no-go areas

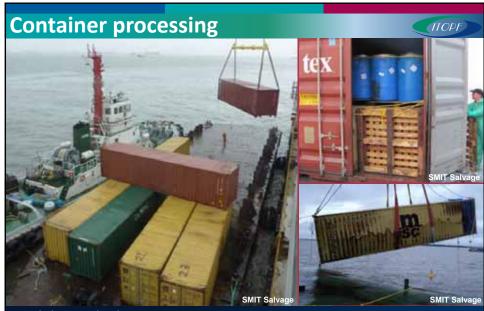
- Ability to discharge containers
- Salvors chartered all available barges
- Delays to salvage operation
